# TRIP REPORT

## CIVIL ENGINEERING DIVISION VISIT

Station visited: LORSTA KARGABURUN, TURKEY

Dates of visit: 30 SEP to 7 OCT 85

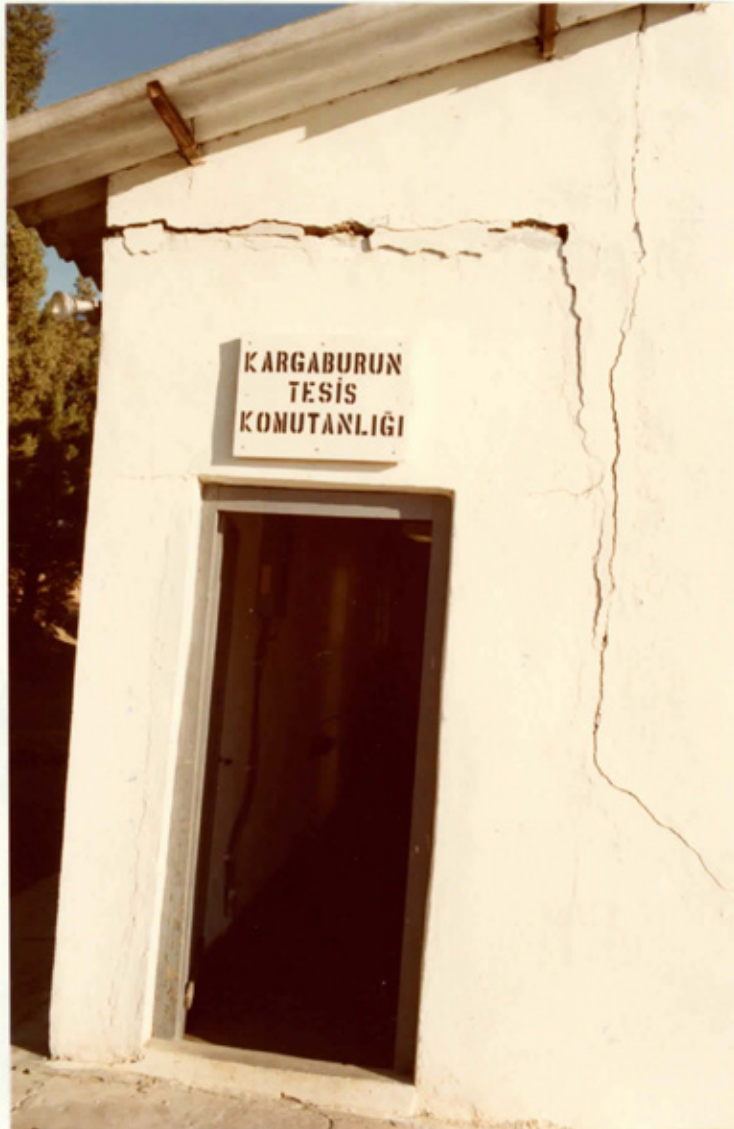
2.5.1 Building is cracking badly. In places the cracks have progressed through the entire wall and the interior of the barracks is exposed.

1. This photo shows a typical crack on the exterior wall that generally extends through to the interior of the building.

It is obvious that if the barracks continue to deteriorate, maintenance and/or replacement will become a serious issue and a decision will be forced. If a minimum amount of materials and tools were procured for minor repairs, it is possible this decision could be postponed for a undetermined amount of time.

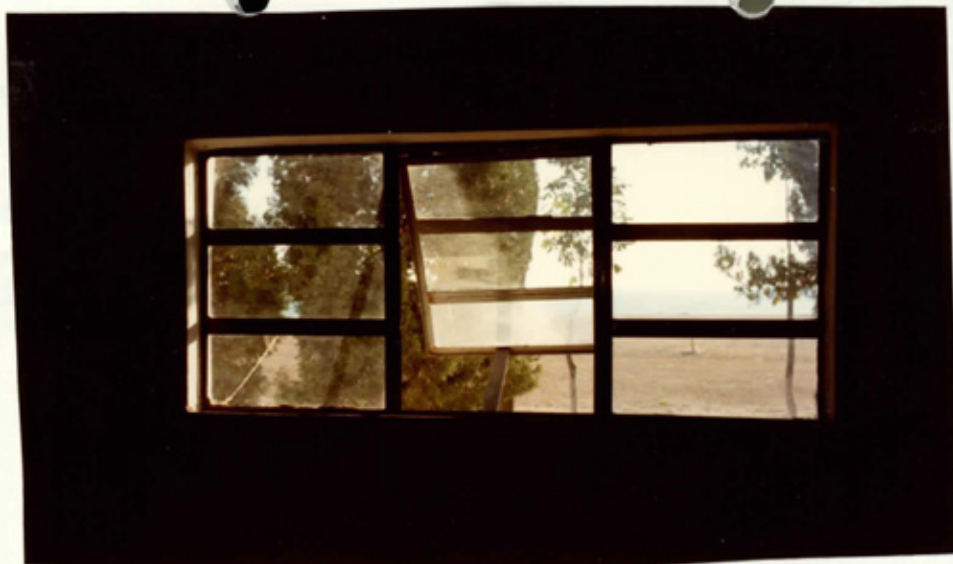
2.5.2 Windows do not close. Air can pass through numerous gaps, cracks, etc.

2. Typical windows in Turkish barracks.

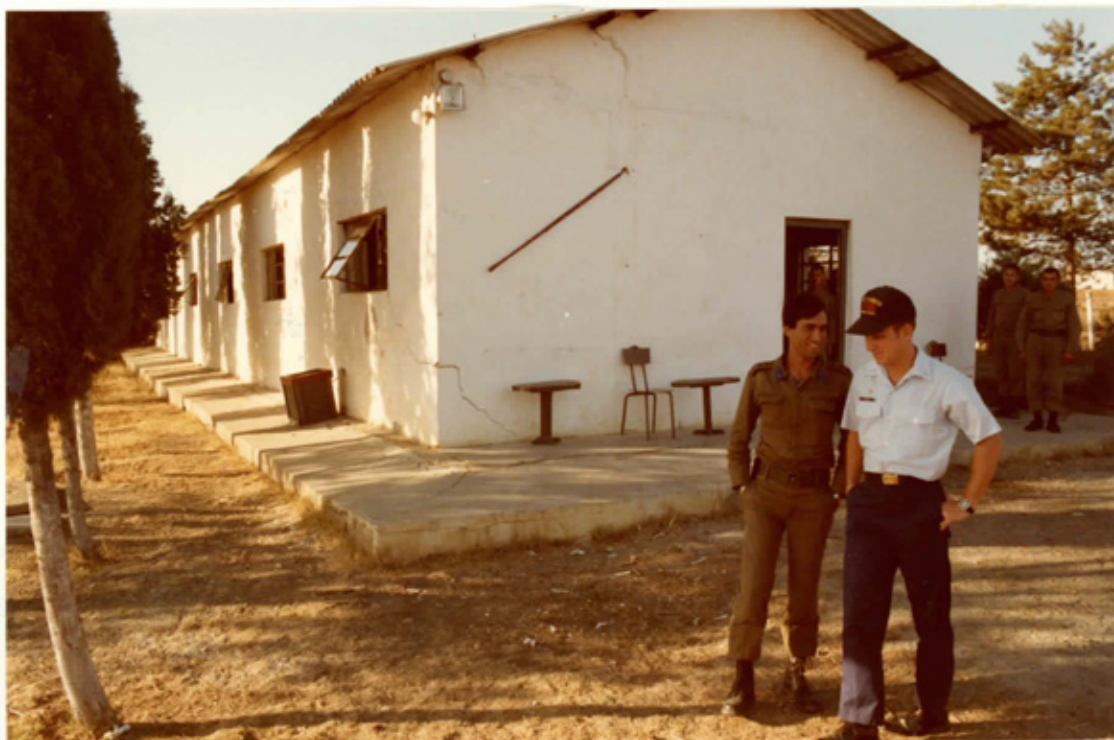
2.5.3 No fiberglass insulation for the areas between the roof and exterior wall. Again, air can pass freely through the barracks.

3. Overall view rear of building. Note cracks, window space in between roof and outside walls.

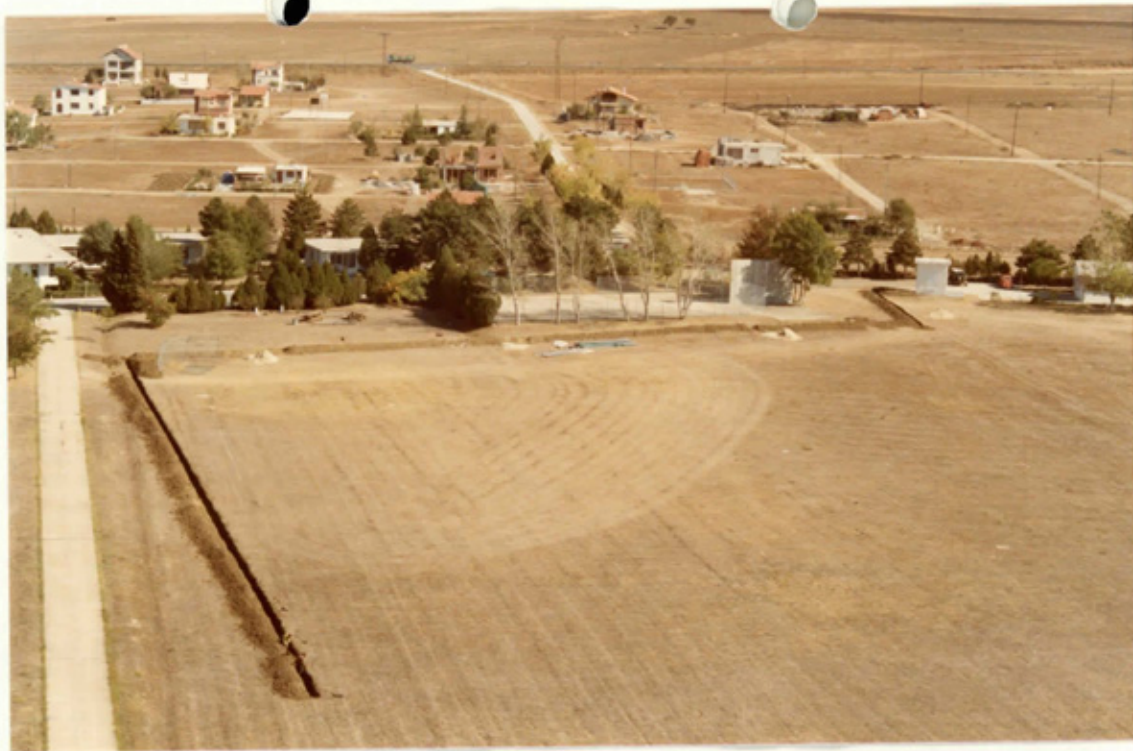
4. View the tower of the freshwater pipe project in progress. This trench is to supply water to the beach house.

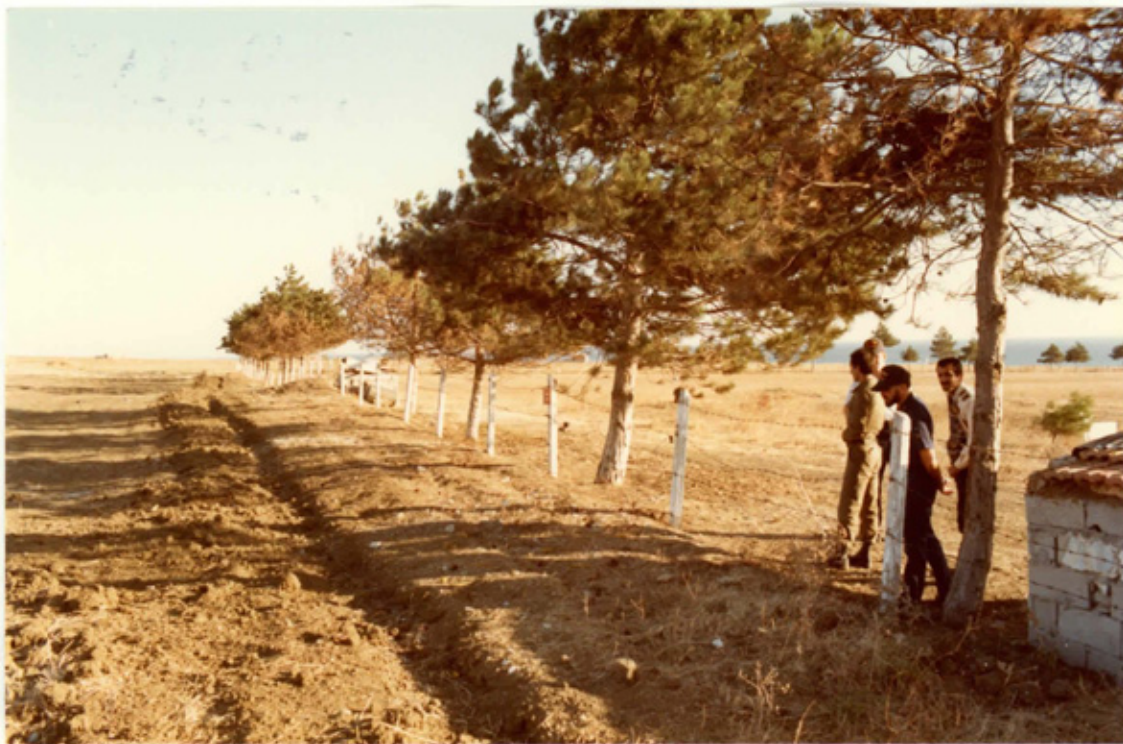
5. View of the fence line across the front of the station by Turkish barracks.

2.4.2 Recommend we proceed with either option 1 or 3, for the reasons stated previously. Also I firmly believe that a 1.5 meter fence is adequate for the needs of the station. If a professional terrorist organization makes an attempt on the station, the fence height will have no prohibitive effect. Increased lighting on the perimeter to be used only when needed such as an emergency medivac etc. would be more effective.

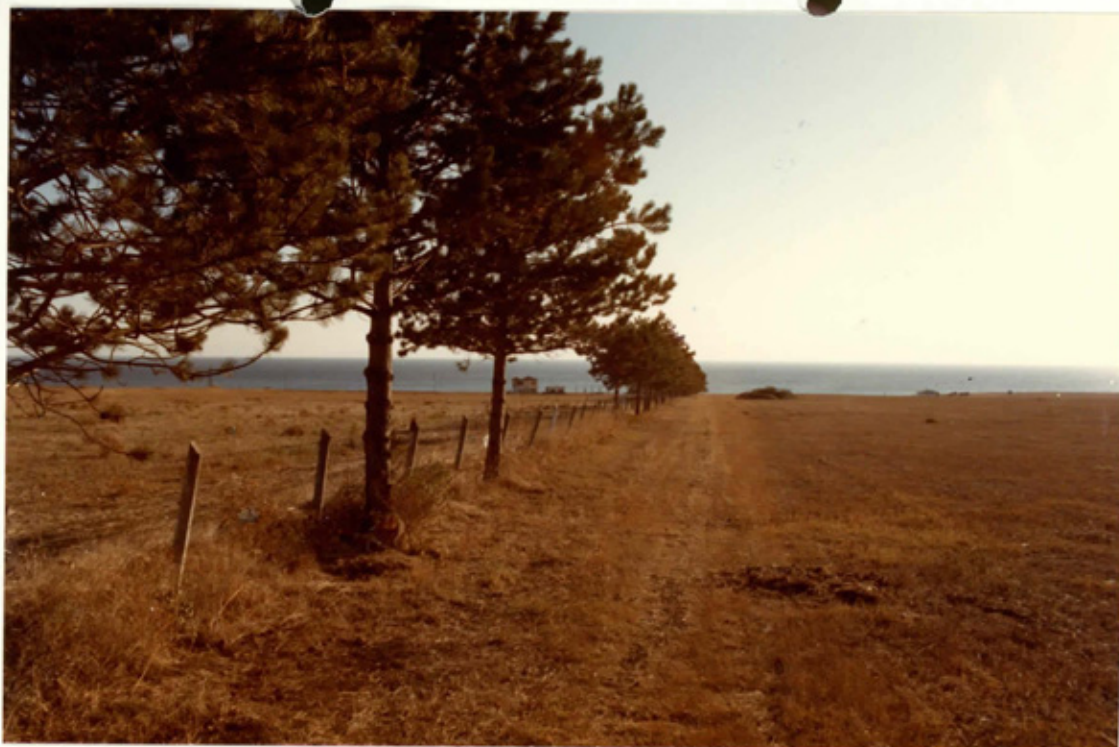
6. Northwest corner of fence line.

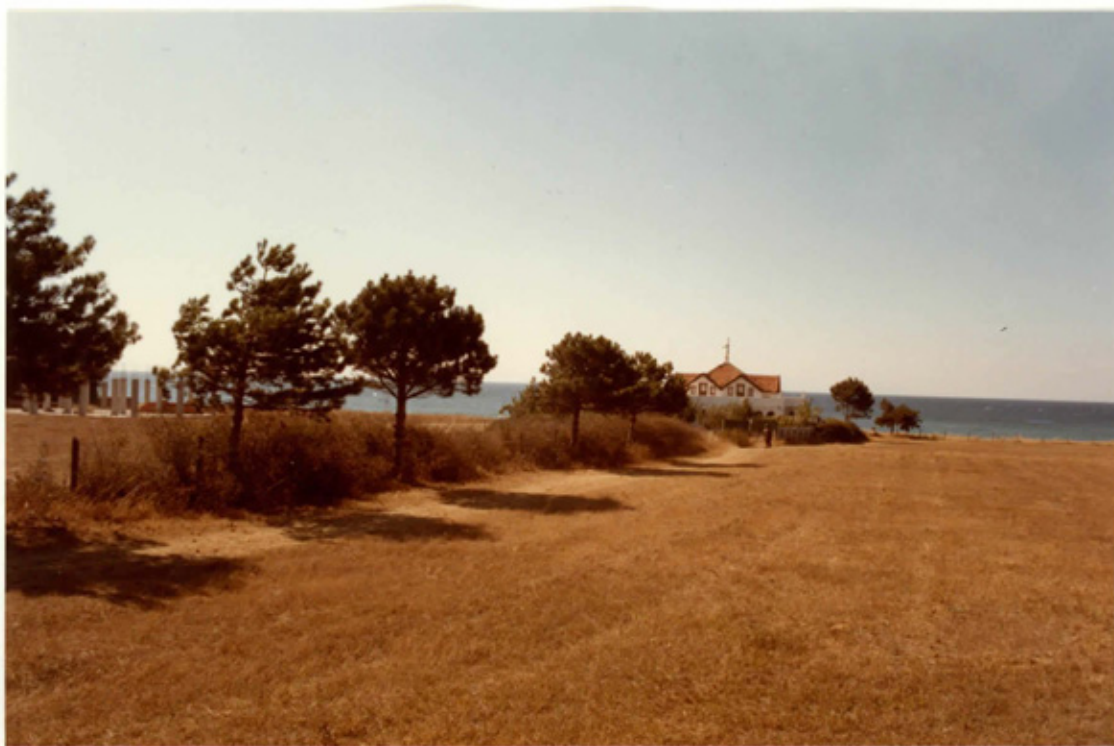
7. Southwest corner of fence line.

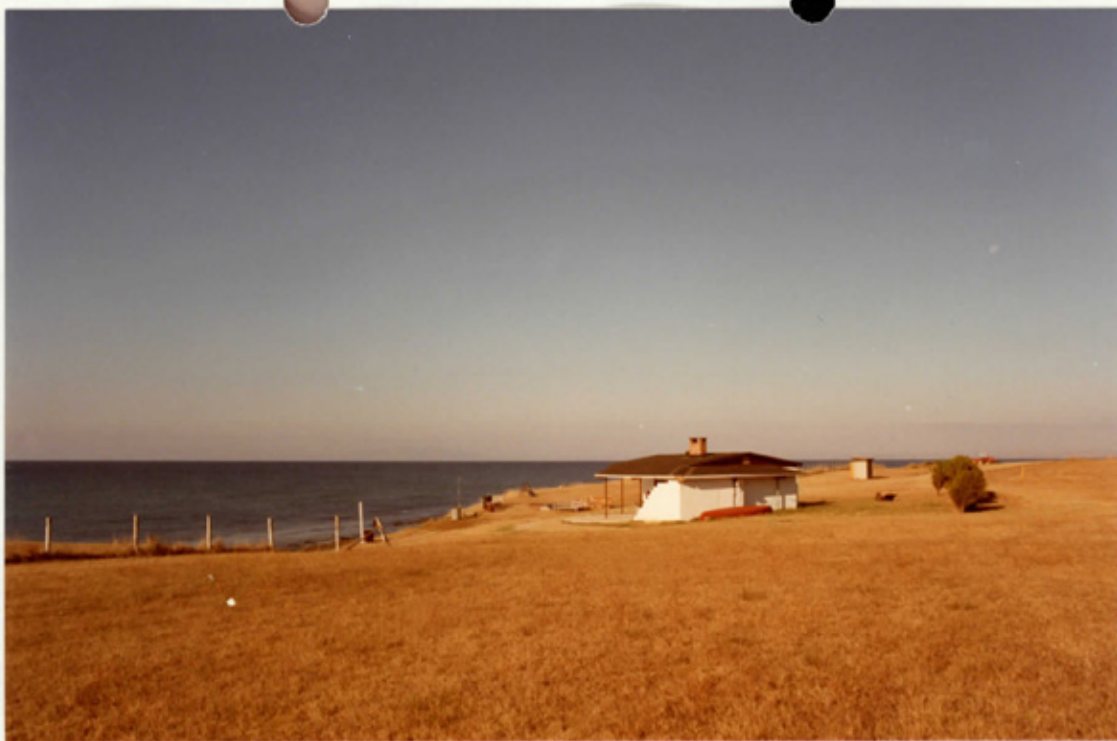
8. Fence line that continues along the back  
(south of the station) by the beach.
