United States  
Coast Guard

From: CWO4 W. G. Hamilton Jr.  
To: Chief, Navigation Division  
Via: Chief, Loran-C Branch  
Chief, Transmitter Section  
Subj: LORAN STATION ATTU AN/FPN-44B INSTALLATION SUMMARY  
Ref: (a) CG EECEN ltr of 11 Aug 1992

1. Purpose of the trip to LORSTA Attu was to finish installing the AN/FPN-44B transmitters, and change over the operating system from AN/FPN-42 to the AN/FPN-44B.

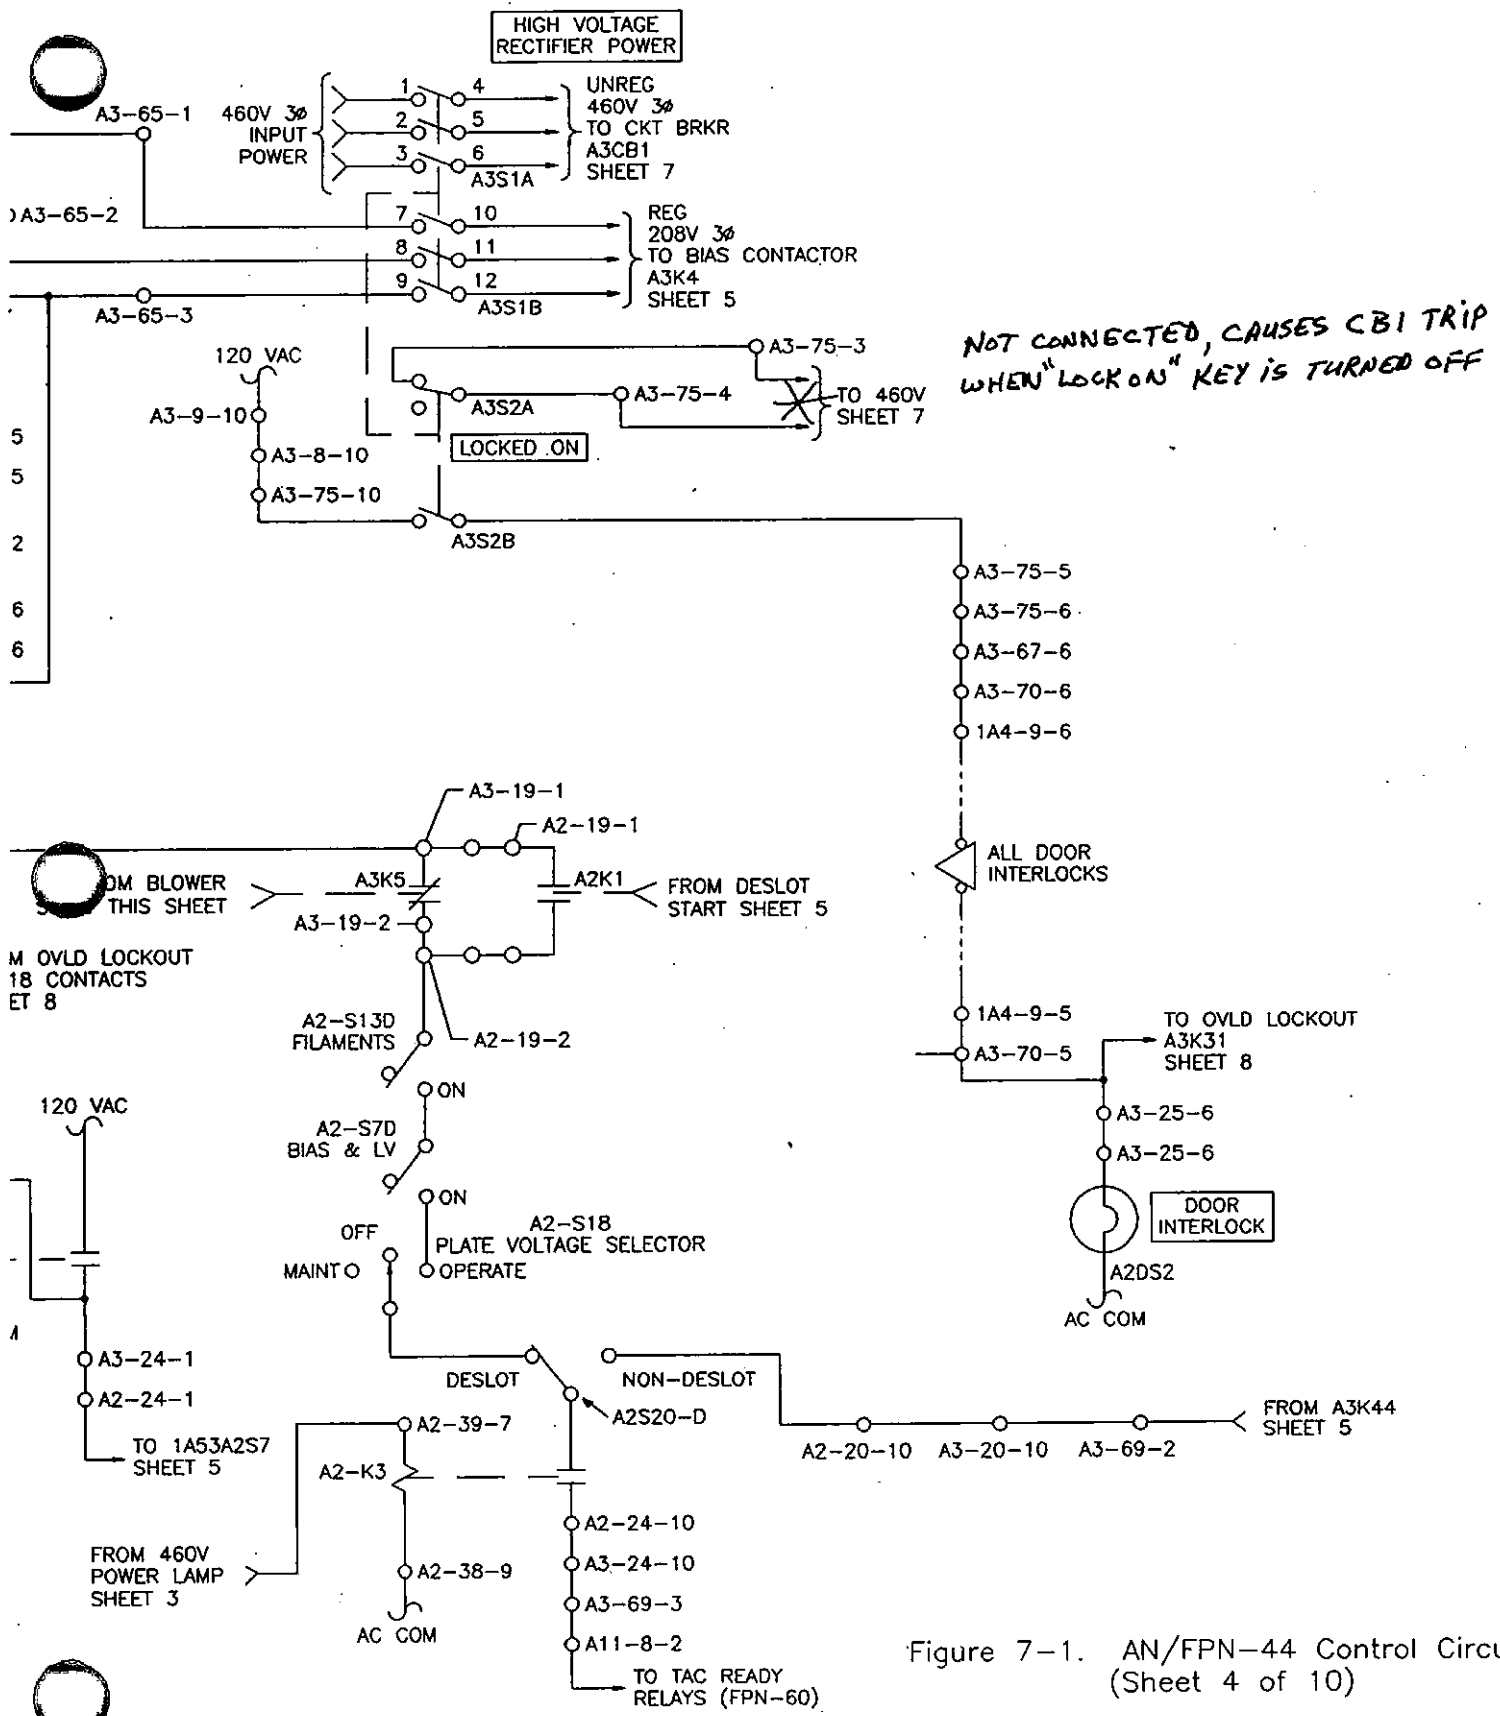
Figure 7-1. AN/FPN-44 Control Circuitry (Sheet 4 of 10)

1. The AN/FPN-44B transmitters at Attu were wired according to the installation instructions, and prints. During electrical checkout it was noted that the 460 volt breaker 1A53A3CB1 would trip every time we turned the "locked on" key switch 1A53A3S2 to off position. This indication is not consistent with other 44 transmitters in the field. It is quite common to operate S2 from "on" to "off" to gain access to the master key block without having to turn off CB1 before turning S2 to off. CB1 is a mechanical device that will wear out if operated excessively, and the CB1 trip from S2 being turned off is a redundant, and unnecessary feature. When S2 is placed to the "off" position the door interlocks are interrupted, and all high voltage within the transmitter is turned off. We removed the link from S2 to CB1's under voltage trip circuit at S2. We covered the wire connectors removed from S2, with heat shrink, and tye-wrapped them back for safety.

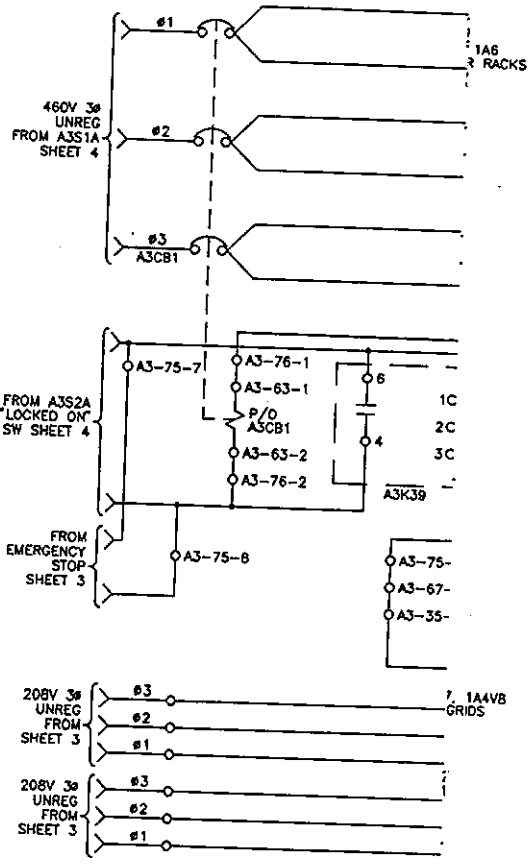
Figure 7-1. AN/FPN-44 Control Circuitry (Sheet 7 of 10)

\* NOT CONNECTED, CAUSES CBI TRIP  
WHEN "LOCK ON" KEY IS TURNED OFF

2. Removal of this feature does NOT create any equipment, or personnel safety concerns. S2, when turned to off, continues to open up the door interlock circuit, and thus removes any high voltages present within the equipments. Knife switches 1A53A3S1A, and S1B continue to operate normally thus ensuring that 460, and 208 to bias circuits are removed from the transmitter before the technician can access the master key block to get a key for high voltage sections.

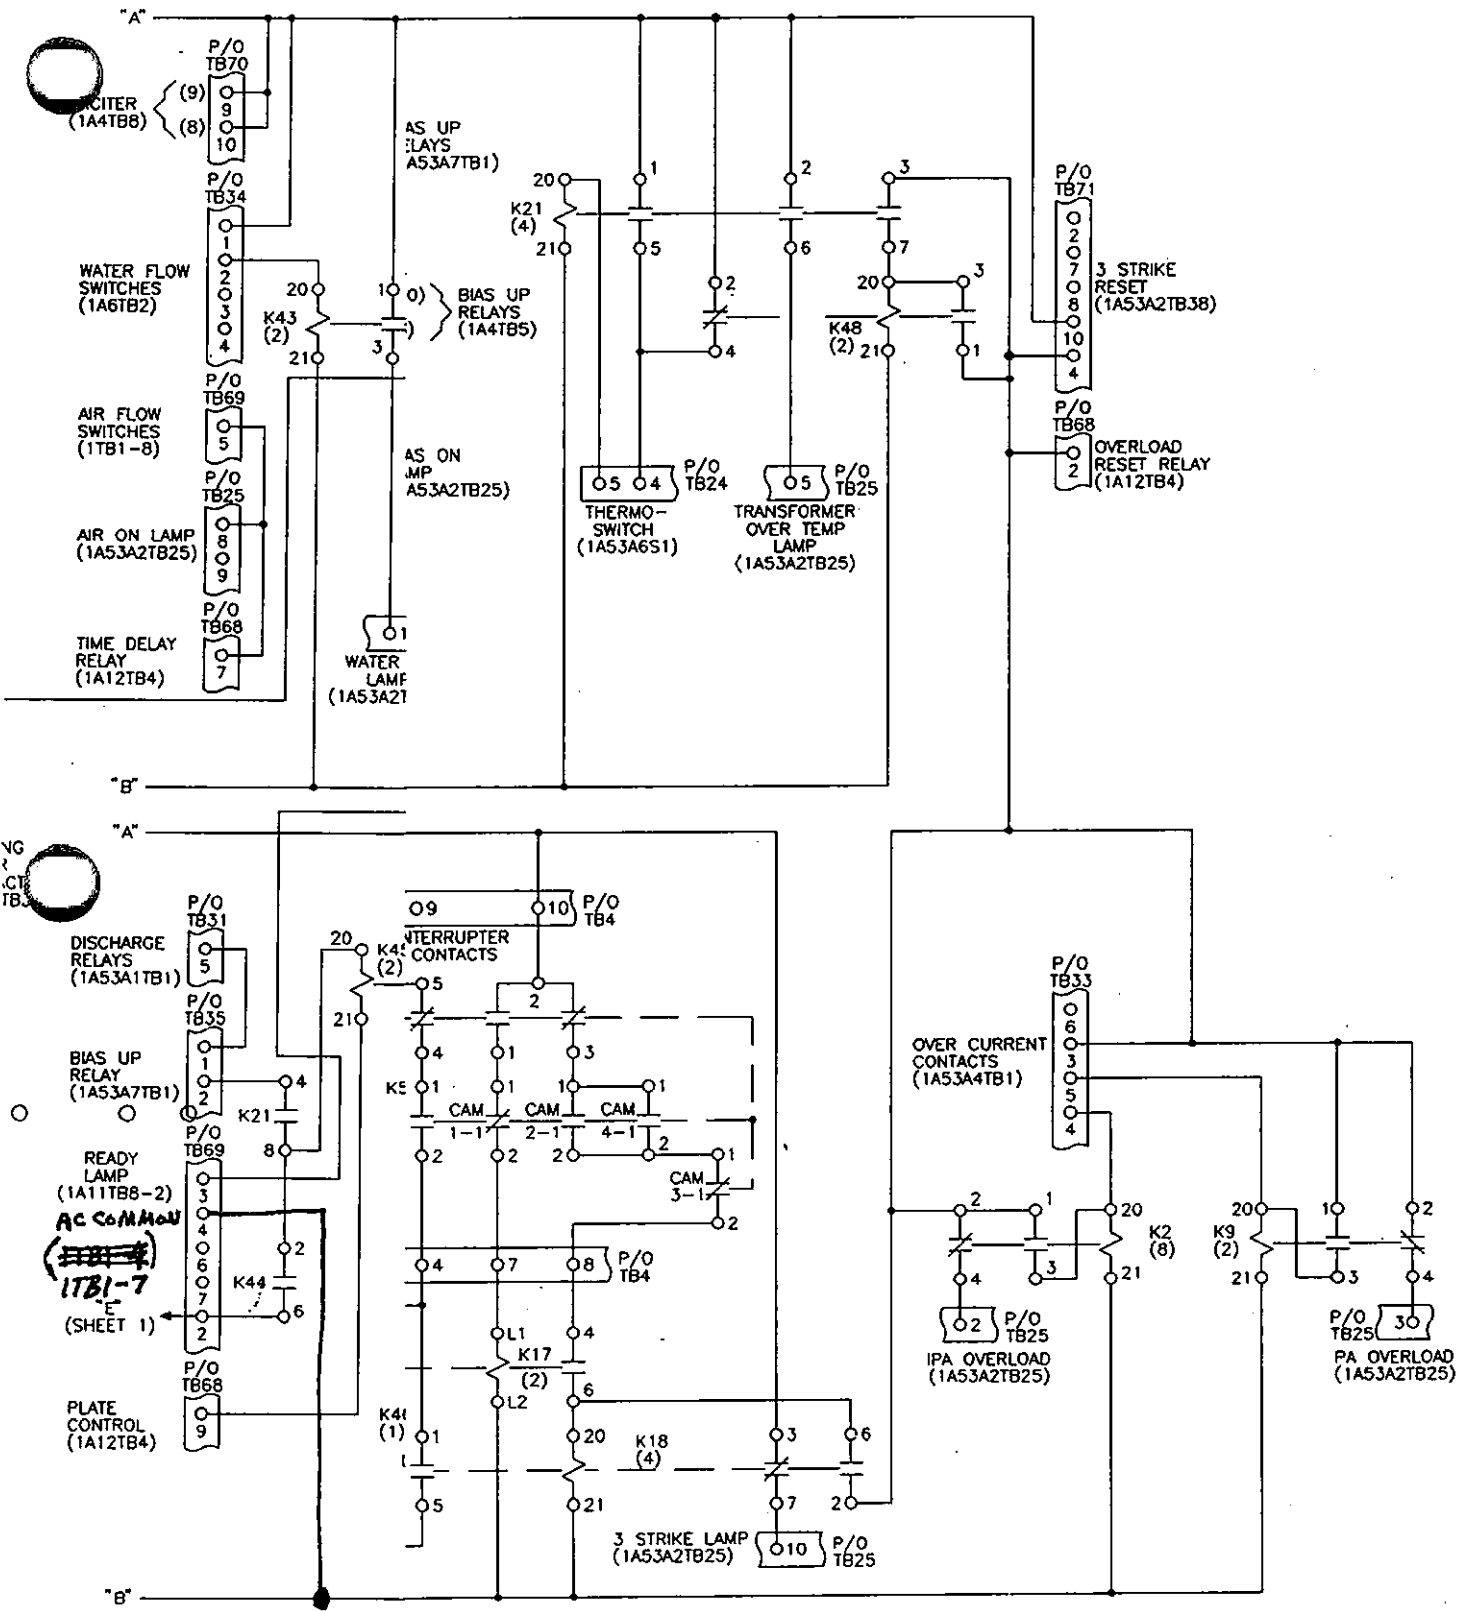
Figure 7-39. 208-Volt Rack Assembly, P/O Relay Assembly RE-1113/FPN-44A(1A53A3), Schematic Diagram (Sheet 2 of 2)

1. EECEN installation efforts resulted in the addition of an Agastat relay in the main enclosure blower air interlock shutdown system to allow proper auto restart following a momentary power failure.

3. EECEN installed a 20 to 200 second "delay upon energize" Agastat relay model #7012AE set to 30 seconds delay to bypass 1S1 main enclosure blower sail switch. This allows the transmitter to auto restart while the dampers are continuing to open fully. At the end of the 30 second bypass period the Agastat relay energizes, and allows sail switch 1S1 to operate as designed.

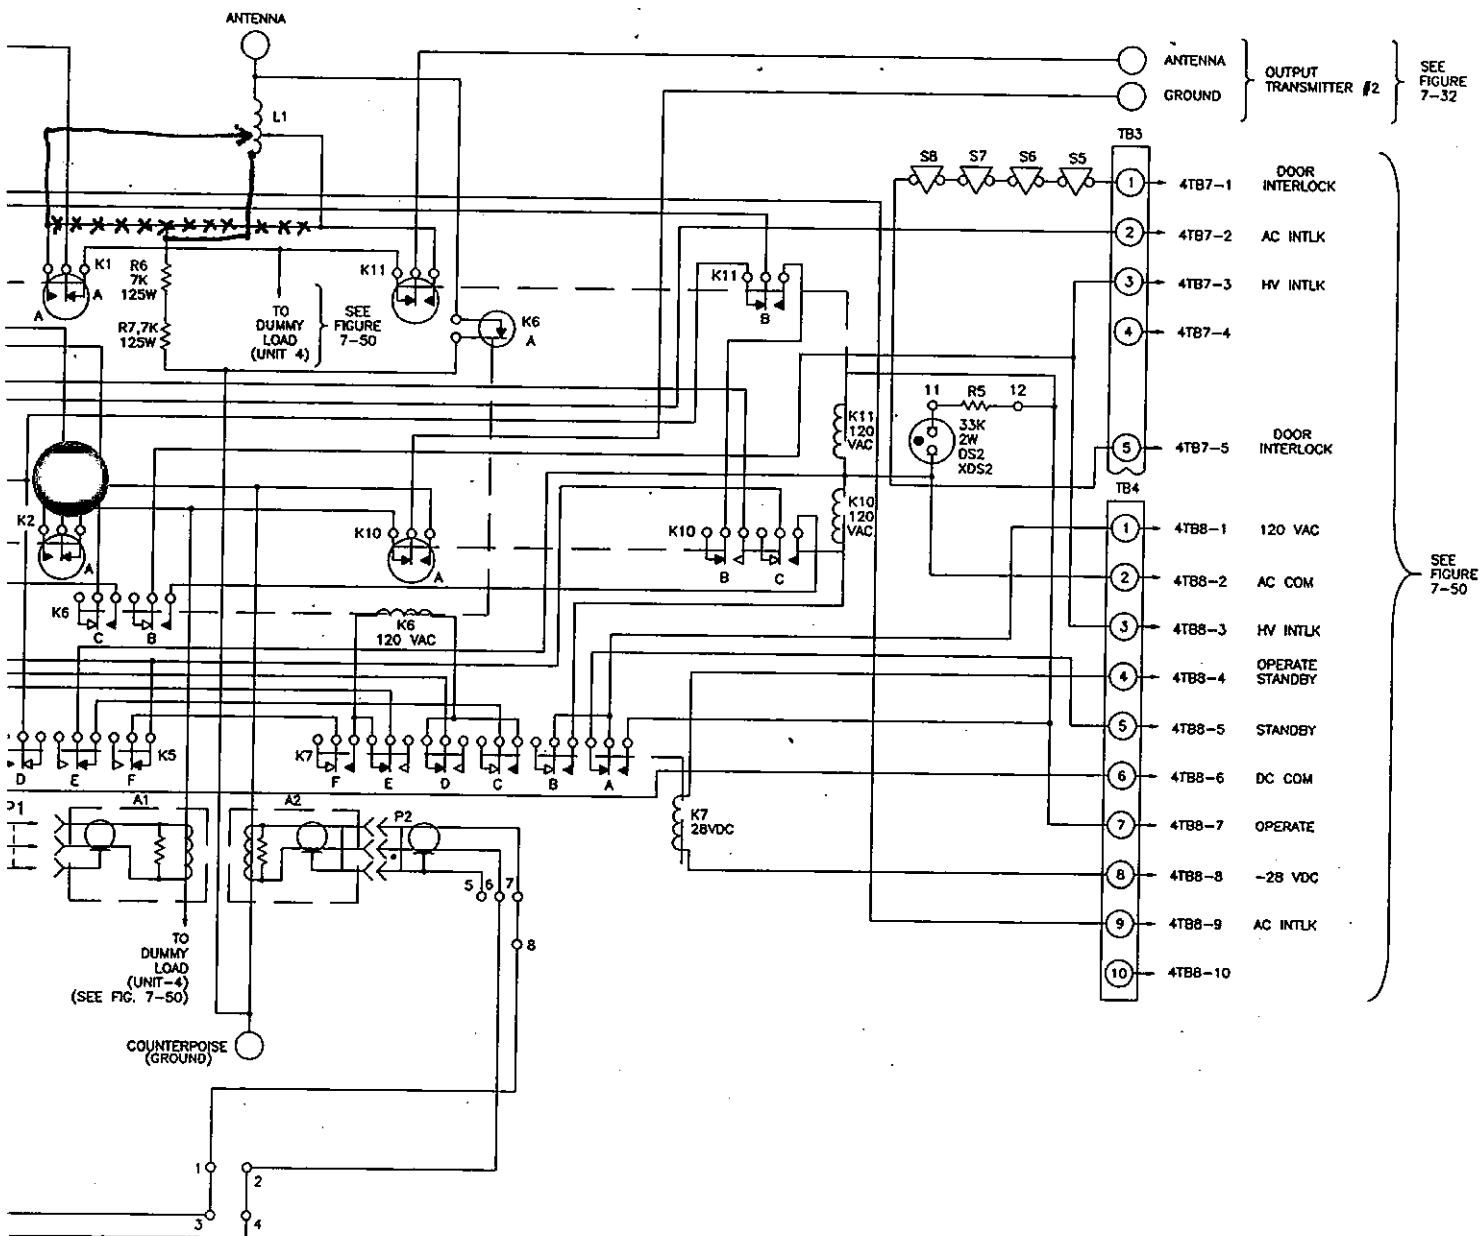
Figure 7-49. Antenna Coupler CV-2174/FPN-44 (3), Schematic Diagram

1. EECEN installation personnel modified the antenna coupler at Attu to allow a better match between the transmitters, and the antenna. EECEN departed from the historic single tuning coil tap to an improved double tuning tap arrangement.

2. Historically, when tuning a transmitter set to the transmitting antenna, one would find the best tune point for the #1 transmitter, and mark the spot on the coil. One then would find the best tune point for the #2 transmitter, and mark that spot on the coil. The final coil tap position is the center of the difference between the 2 spots on the tuning coil which results in neither transmitter being really correct, but both being close. EECEN has added an additional tap to the network to allow each transmitter to be precisely tuned for it's best match to the transmitting antenna.

4. Lorsta St. Paul, and Port Clarence will be installed with the same double tap arrangement. The attached schematics shows the double tap wiring arrangement.
