French Frigate Shoals LORSTA; report of storm damage

Subj: Storm damage at Loran Transmitting Station French Frigate Shoals

LORAN TRANSMITTING STATION FRENCH FRIGATE SHOALS
STORM DAMAGE 10-11 JANUARY 1954

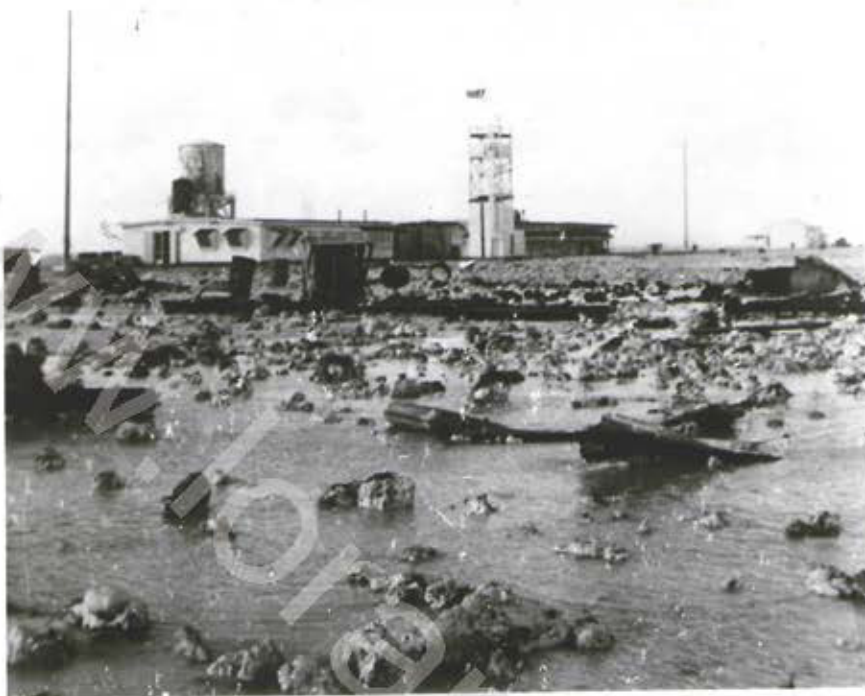
1/11/54. Debris
washed on runway.

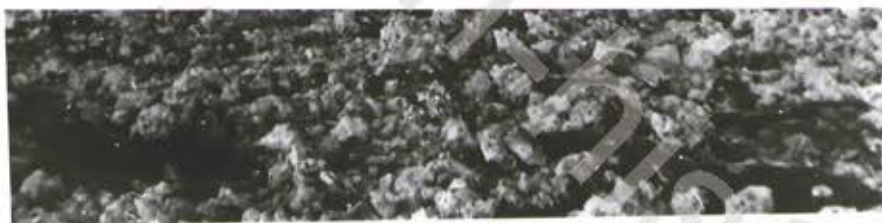
1/11/54. General
view of runway, look-
ing east.

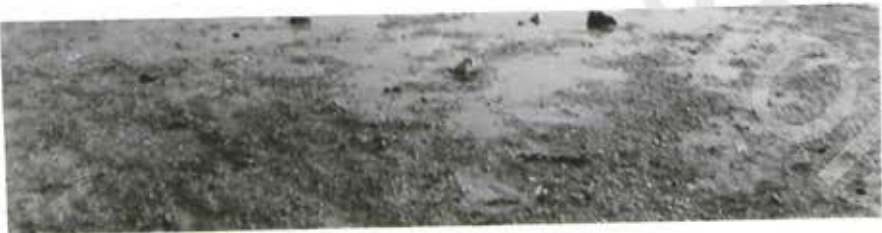
3. A survey was also made of the island, and the sheet piling bulkhead was found to be weakening at many places. The bulkhead was constructed during World War II, probably prior to 1944, and in the intervening 10 years corrosive conditions prevailing at the island have eroded holes completely through the steel section at many places (see photograph, enclosure 2). Seven plans were developed for improving conditions at the island and for relieving the threat of loss of portions of the island in the next few years. The plans are summarized on enclosure 1, and are shown on the attached drawings, enclosures 3 to 7. Consideration was also given to constructing groins along the northern side of the island but in the absence of littoral drift to feed the groins it appeared impractical to install them. In addition, mobilization of adequate equipment to install the groins would be approximately equal to that required for a program of replacing the sheet piling bulkhead.

2/26/54. Erosion
behind failed
piling, North side
of island.

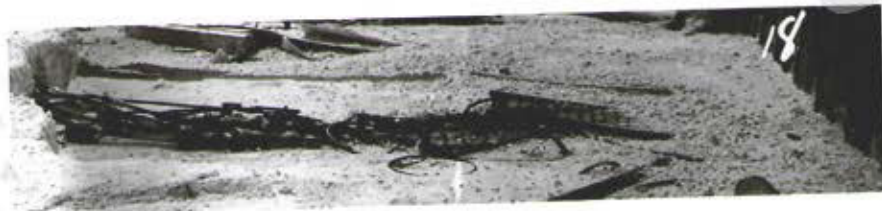
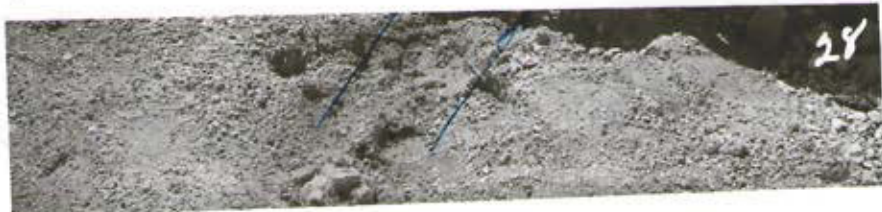
2/26/54. Corroded
piling, NW corner of
island.

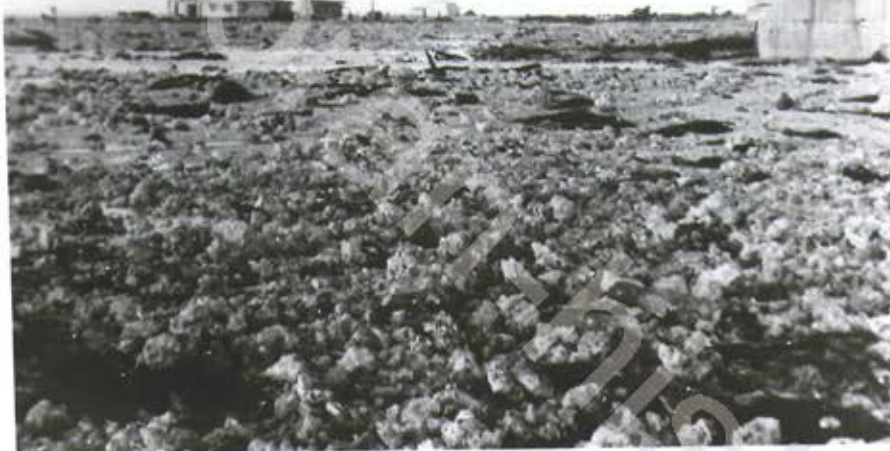
1/11/54. General
view of runway, look-
ing east.

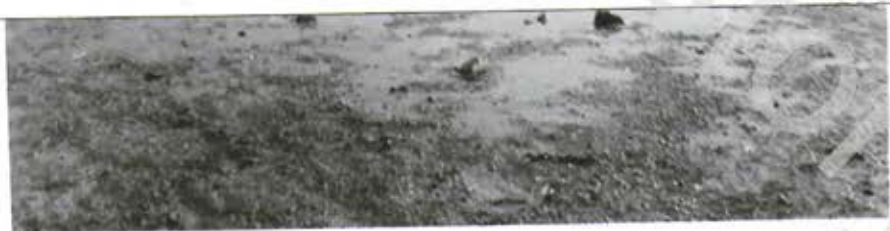
2/26/54. Erosion
behind failed
piling, North side
of island.

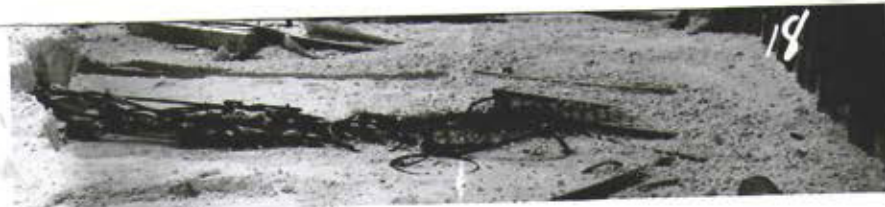
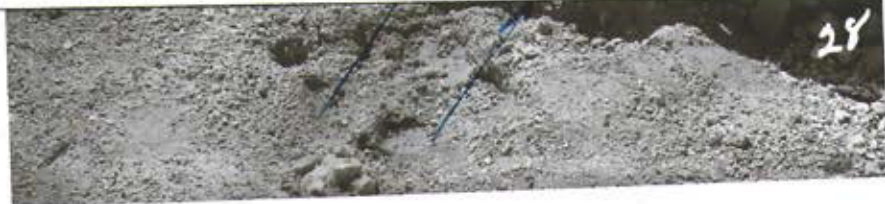
2/26/54. Corroded
piling, NW corner of
island.

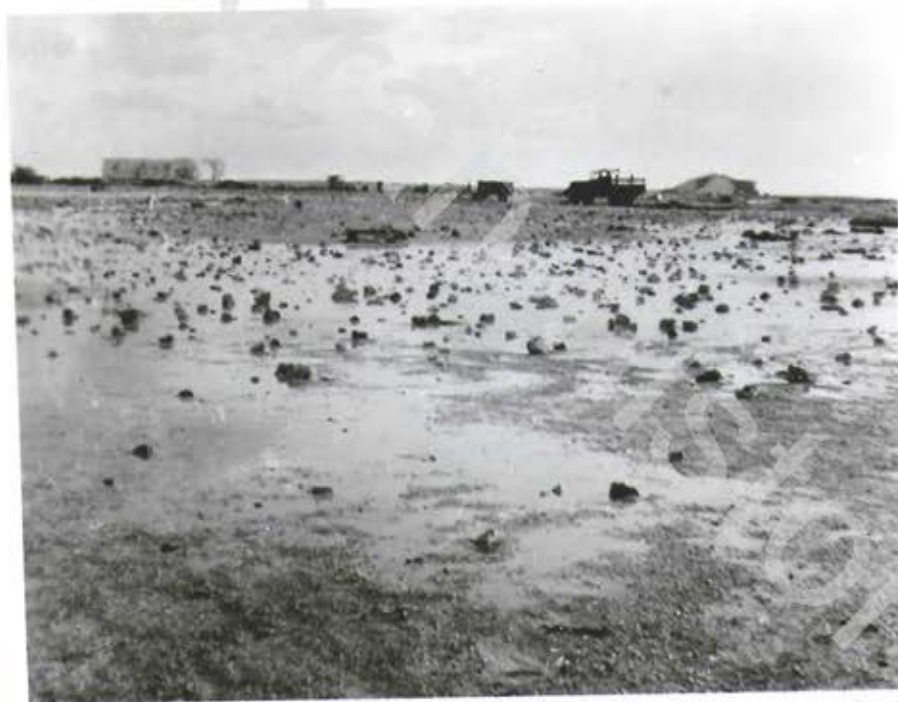
1/11/54. General view of runway, looking east.

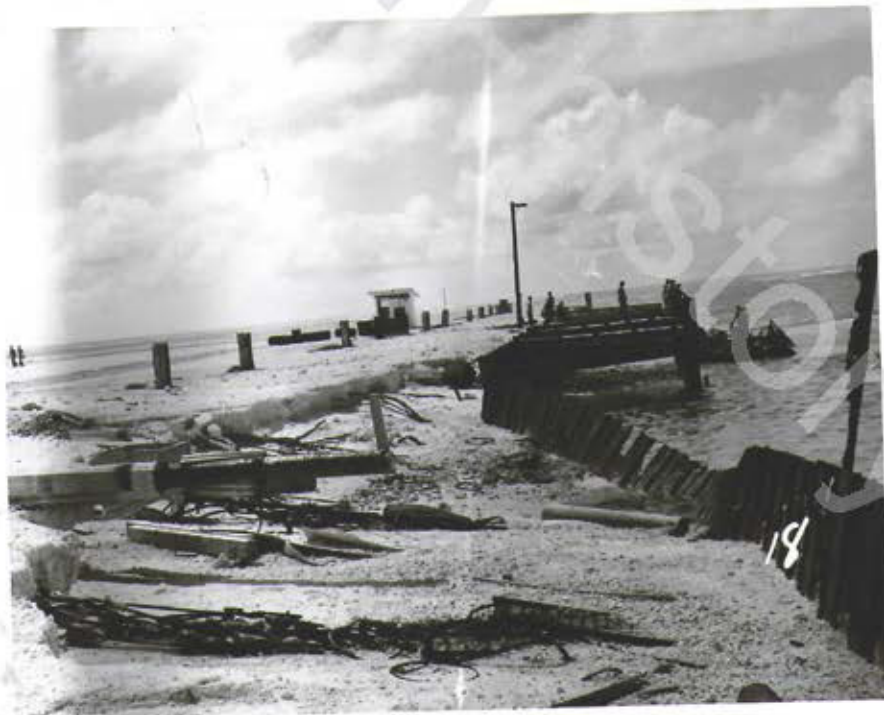
2/26/54. Erosion behind failed piling, North side of island.

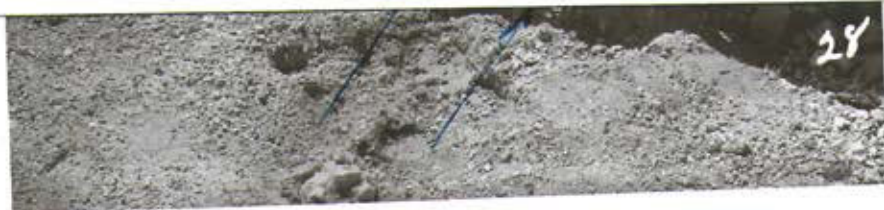
2/26/54. Corroded piling, NW corner of island.
