## RECOVERY AND SALVAGE OF

HC - 130B 1345

*CDR. A.H. Wagner  
Aircraft Repair and Supply Center  
Elizabeth City, North Carolina*

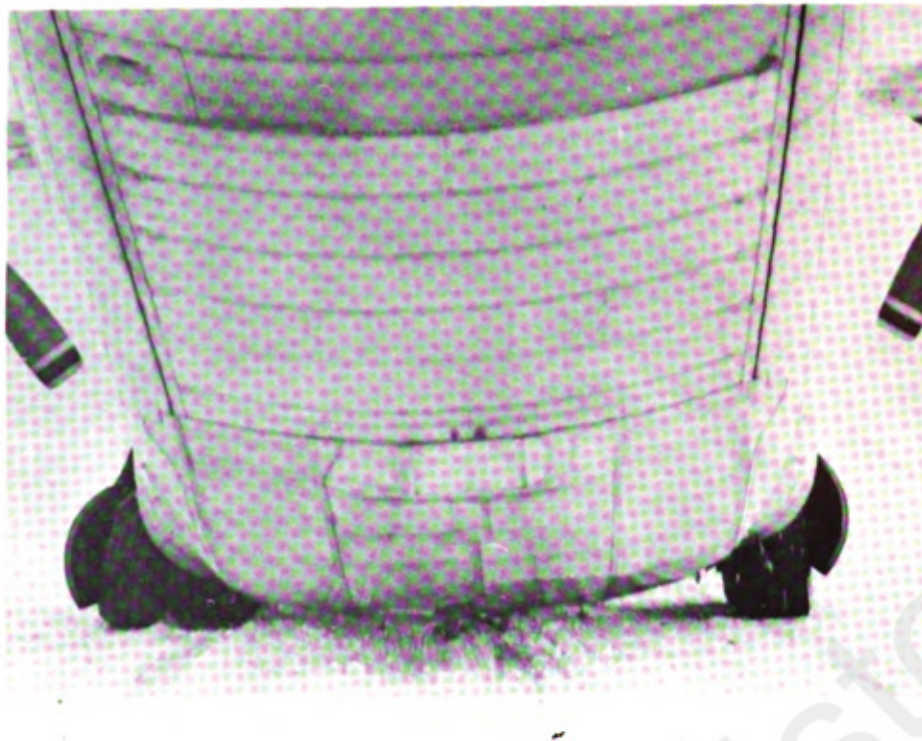
While on a routine logistics and inspection trip to northern Loran Stations, the aircraft was damaged on landing at Cape Christian. The left rear main landing gear had been torn from its track and shelf bracket, the torque strut connecting the two left

main landing gears had fractured, both wheels were deformed and the bottom of the fuselage was holed in several areas from the ADF antennae aft to the ramp.

Figure 1. Aircraft after landing.

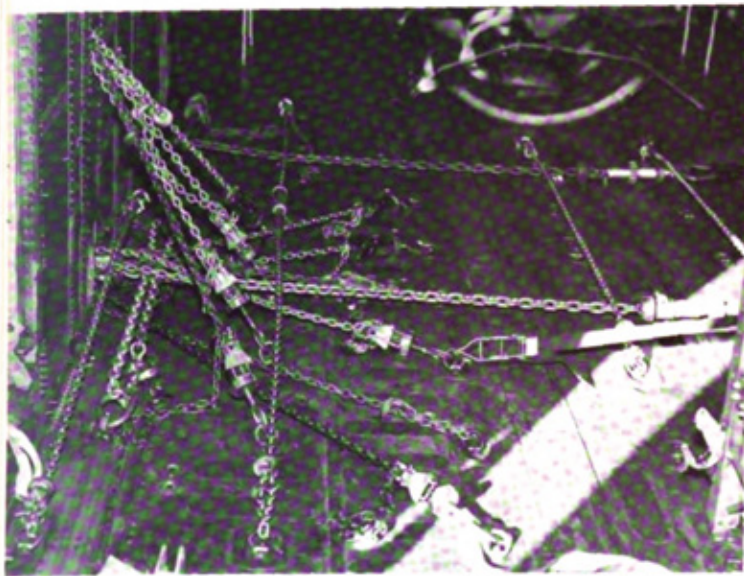
Figure 2a. A complex pattern of tie down chains was devised to retain the strut in position.

It was decided to use cargo tie-down chains, and a complex pattern was devised as shown in figure 2. The pattern was calculated to be capable of withstanding at least a 2g landing. Because of the high winds and frozen ground, no work was accomplished under the aircraft. In the meantime, a search of the Loran Station was being made for any available repair materials. Structural steel of a workable size for splicing severed fuselage frames could not be found. However, the cargo floor was basically intact with only minor cracking near the left chine and calculations indicated that if cargo was not carried, splicing would not be necessary.

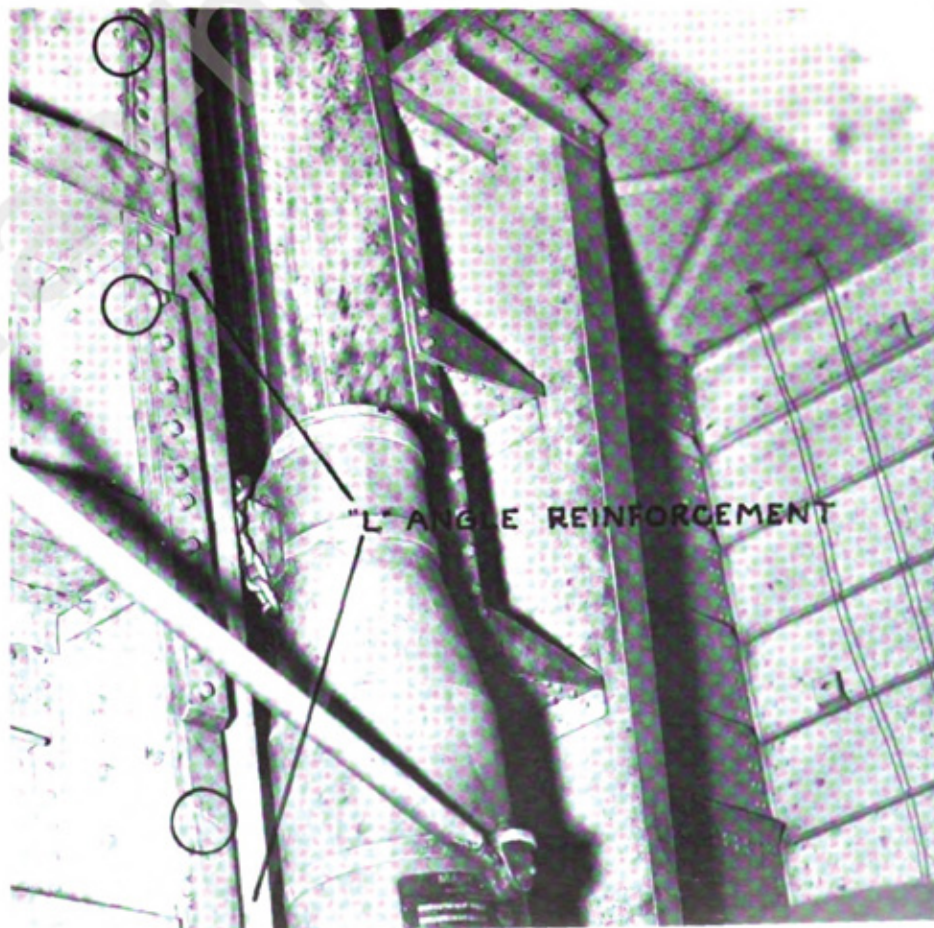
Close inspection of the aircraft while hangared at Thule revealed that the cracks in the landing gear to wing root beam had widened somewhat, and strengthening of the beam would be required. A 48 inch long steel "L" angle was located, and using jet engine turbine casing bolts, it was attached to the rear of the beam as shown in Figure 4.
