Subj: CG LORSTA HAVRE STAFF VISIT TRIP REPORT

Staff Visit Items
from CG LORSTA Havre Visit
of 27 thru 30 August 1990

LORAN Station Havre Tour Comments:

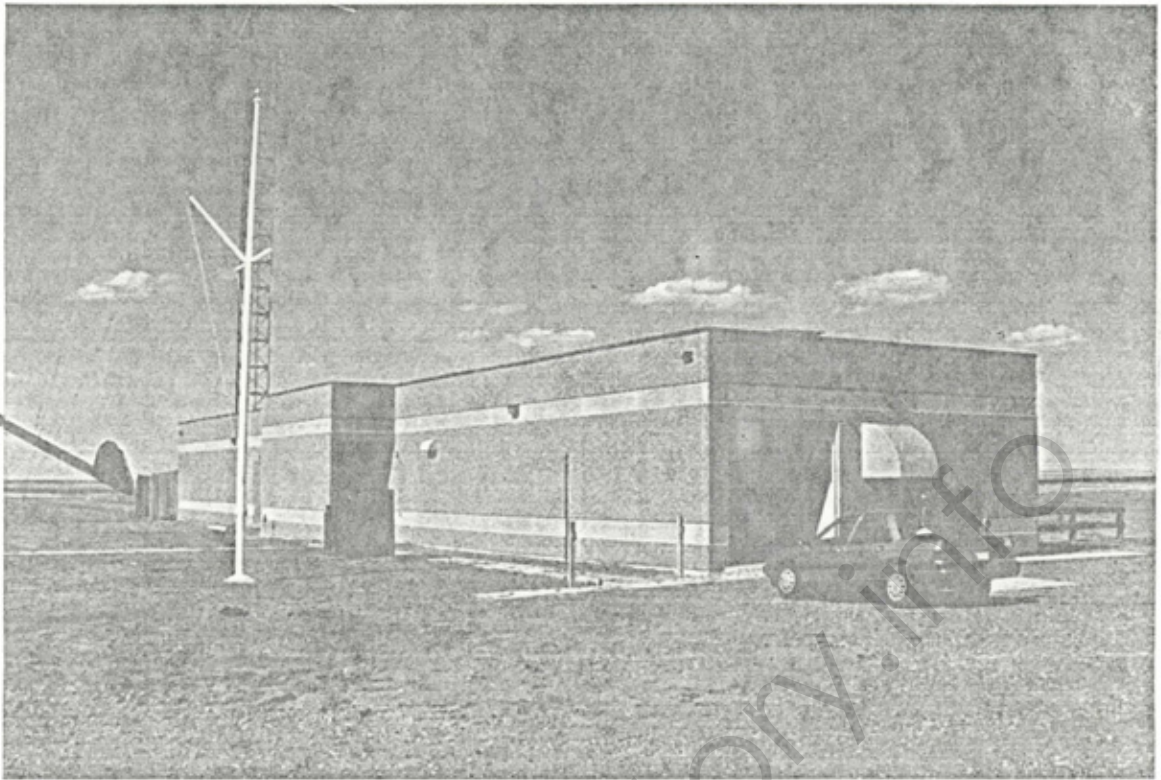
TOWER
FENCE

(3) LORSTA grounds are open to roaming cattle. Residue from the herd is found everywhere. The fence around the tower base has two gates. The west gate has broken away from its supports and has allowed the cattle to enter. The gate is hinged so the prevailing wind forces the gate open in lieu of holding the gate shut. This gate requires immediate attention.

A non-conductive fence should surround the building, receive antenna, ground planes, and tower guide anchor areas, See attachment (1).

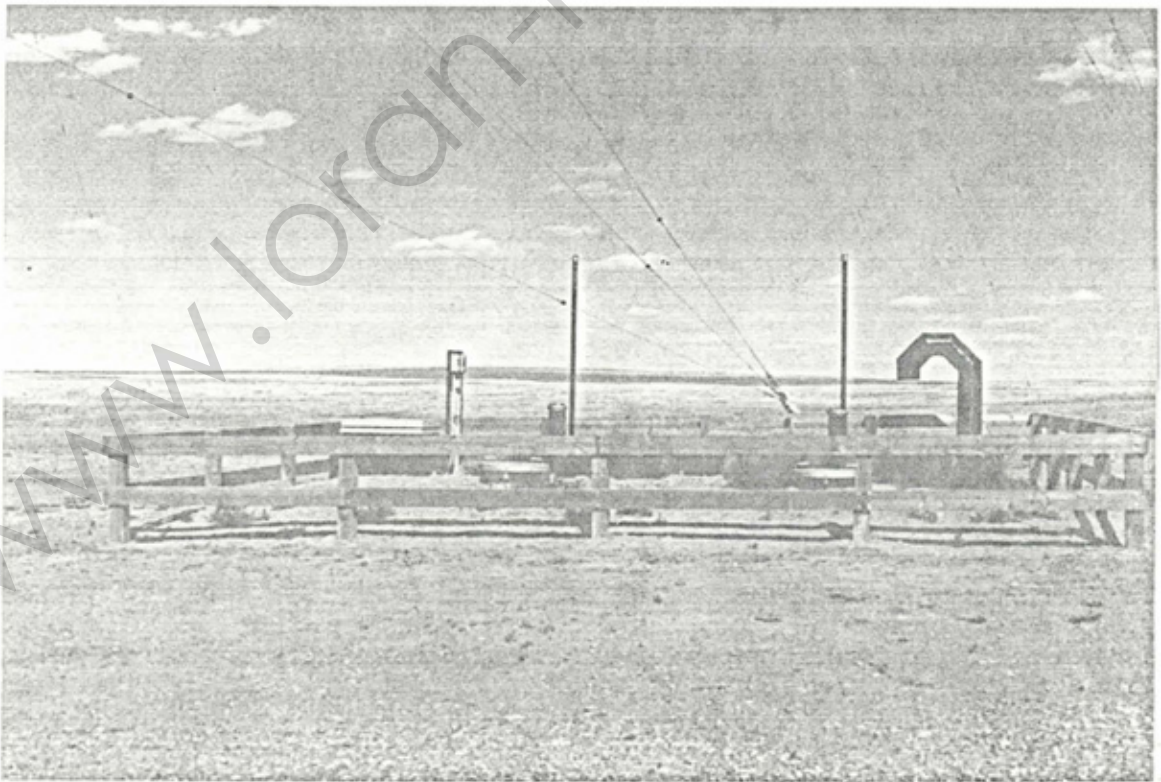
ABOVE GROUND VIEW OF
FUEL VAULT

(4) The emergency generator fuel vault is immense! Two huge fuel tanks are contained in the vault plus ample room to move around, See attachment (1).

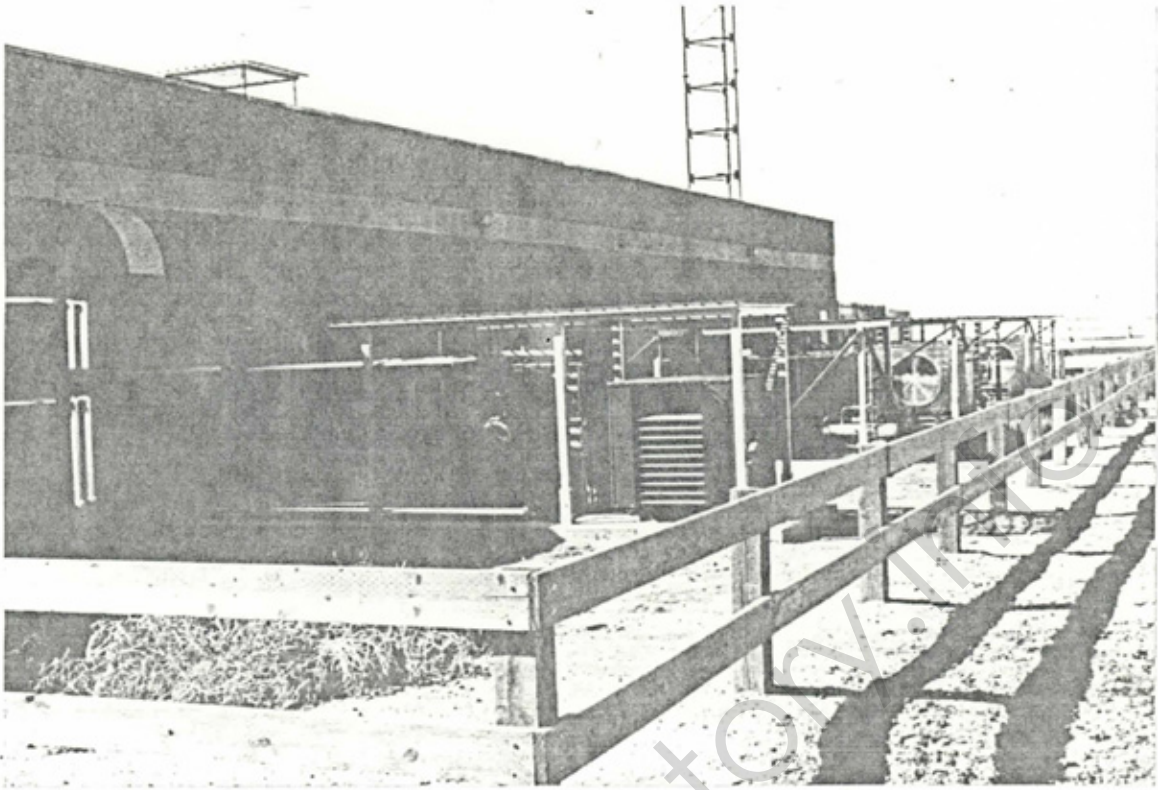
HEAT
EXCHANGER
AREA

(5) The heat exchanger area is plagued with weeds. This type weed tends to break loose with the wind and could clog or damage the radiators, See attachment (2).

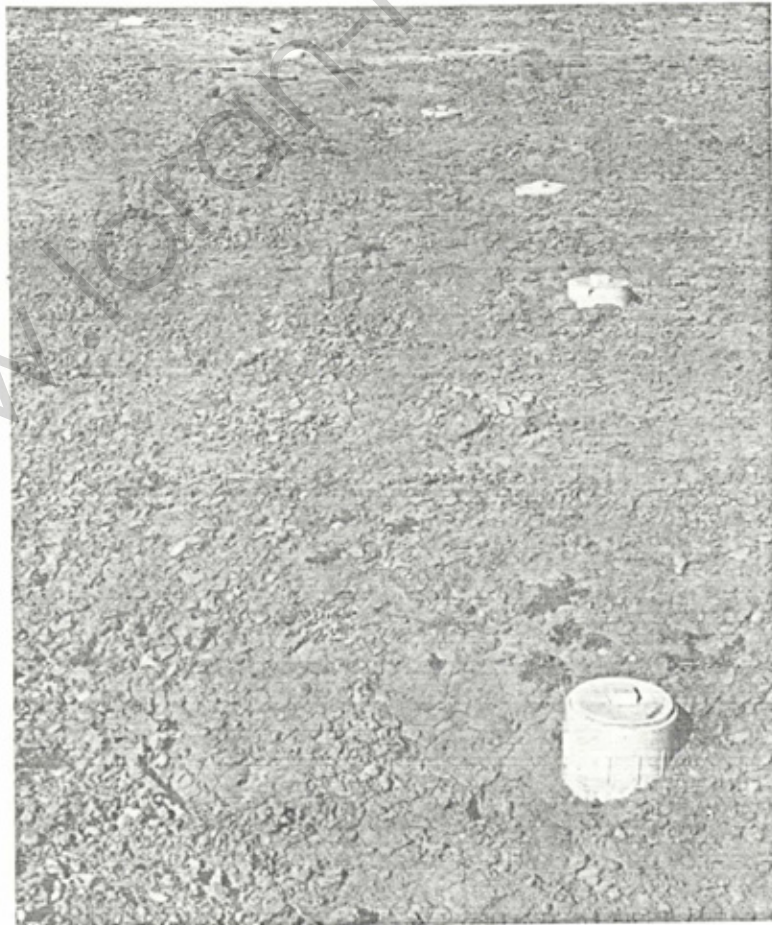
ANTENNA
GROUND
PLANE
PIPE CAPS

(6) The ground rods terminating the ground plane radials are each covered by 6" PVC pipe caps, See attachment (2). These pipe caps are used for the transmitting tower, receive antenna and the monitor antenna ground planes. This is an excellent way to insure access for locating and servicing. Suggest marker stakes be used to locate the pipe caps after the foliage returns.

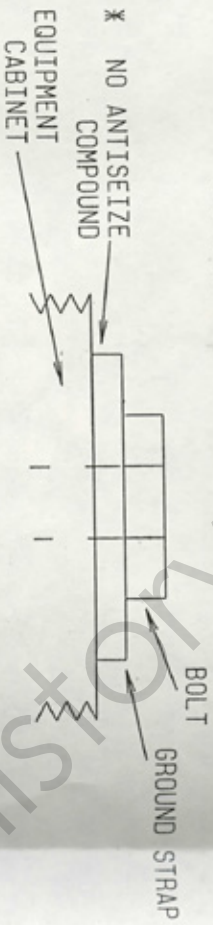
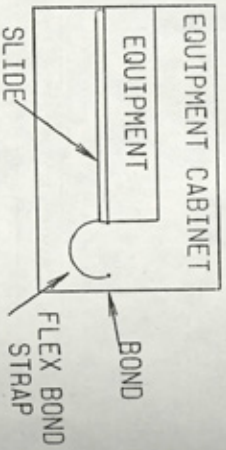
EXISTING CABINET BONDING

E. On 30 August LT Schenk and CWO4 Soula visited the LORAN monitor site with the FAA technician, Mr. Neumann, (406) 452-0815. This facility is at the Great Falls airport. This site is not fully operational. The equipment and receive antenna installations are excellent. I found the electronic equipment chassis, cabinet and rack bonds within the structure not in compliance with MIL-HDBK-419. Electronic installations generally are required to meet these standards to prevent EMI and shunt spurious noise. Suggest all surface to surface (Type three bonds) contact bonds be clear of paint and checked to insure zinc impregnated antiseize compound (MIL-T-22361) was used to reduce contact resistance. Suggest flexible bond straps be installed to allow servicing of the electronic equipment without the necessity of unbolting the bond strap. I suggest copper ground straps be bolted to clean metallic surfaces utilizing washers to insure full and even pressure to the width of the copper strap. See attachment (3) for depictions of bonding suggestions.

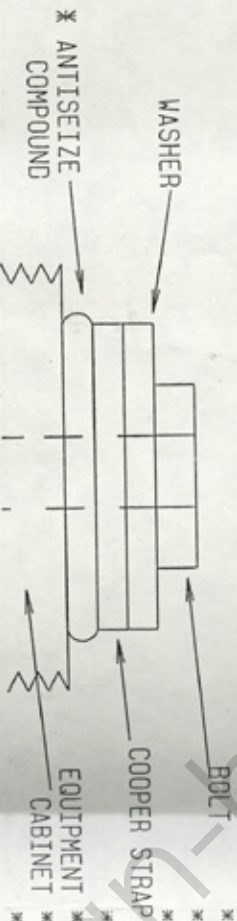
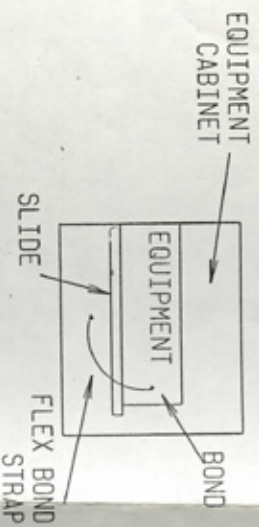
PROPOSED CABINET BONDING

* ANTISEIZE COMPOUND - PETROLATUM AND ZINC DUST TUBE.

8 OZ., MIL-T-22361, SPMIG #0055
NSN #9030002921102

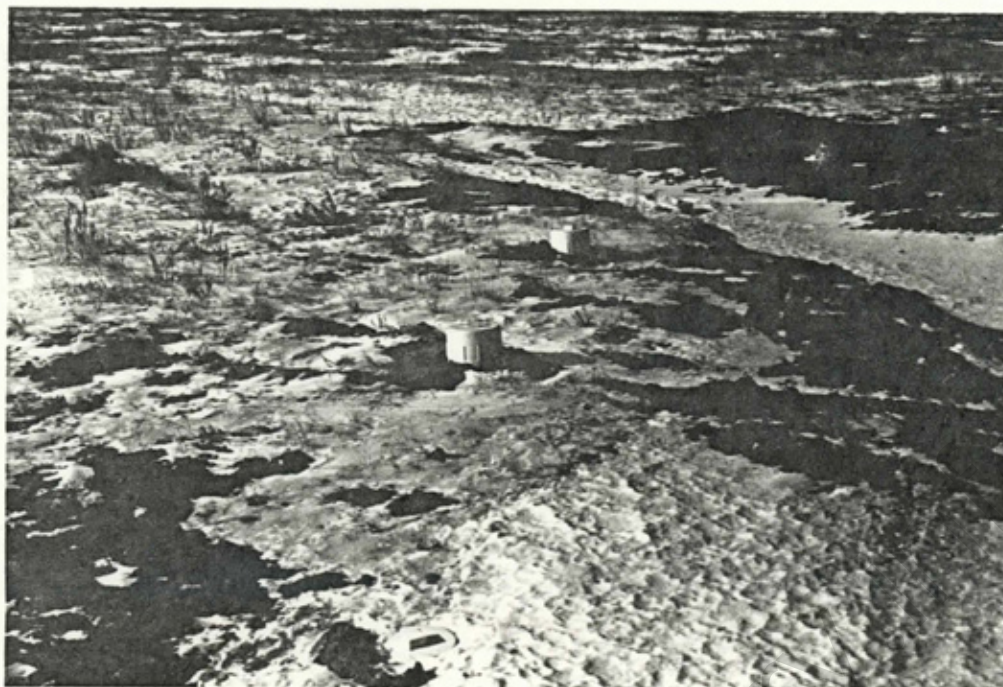
THESE ARE THE TERMINATIONS OF THE ANTENNA
GROUND RADIALS, BOTH TRANSMIT AND
RECEIVE ANTENNAS, AT BOTH THE LORSTA
AND THE GREAT FALLS MONSITE.

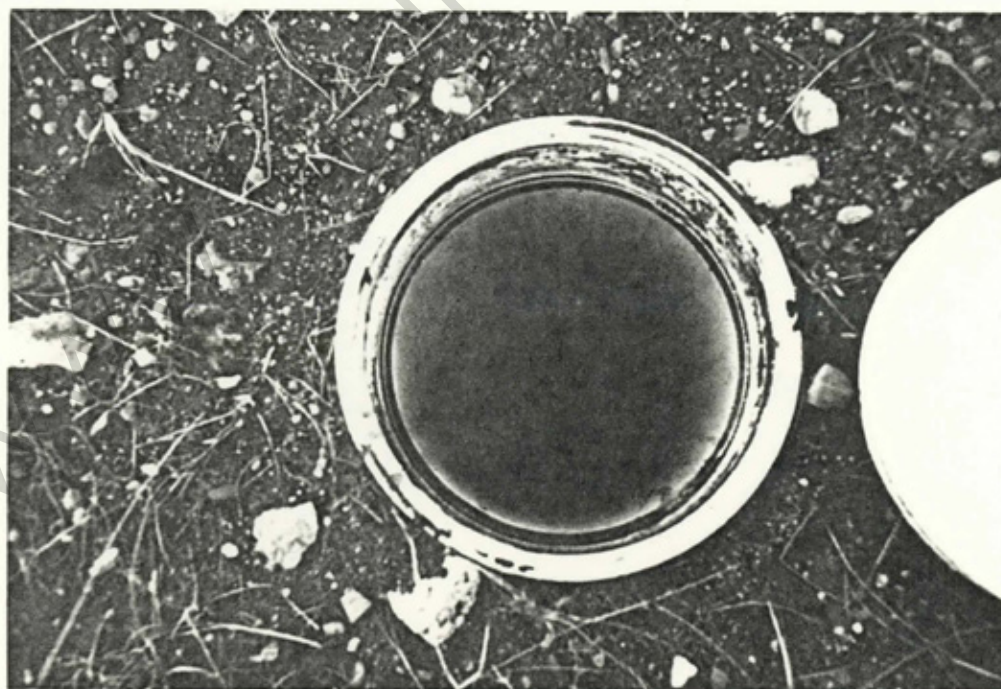
IN THIS PHOTO, THE GROUNDING ROD WITH
THE RADIAL ATTACHED IS SHOWN IN THE
CENTER OF THE PIPE.

GREAT IDEA !!
EASY TO FIND THE RADIALS, MAKE MEASUREMENTS,

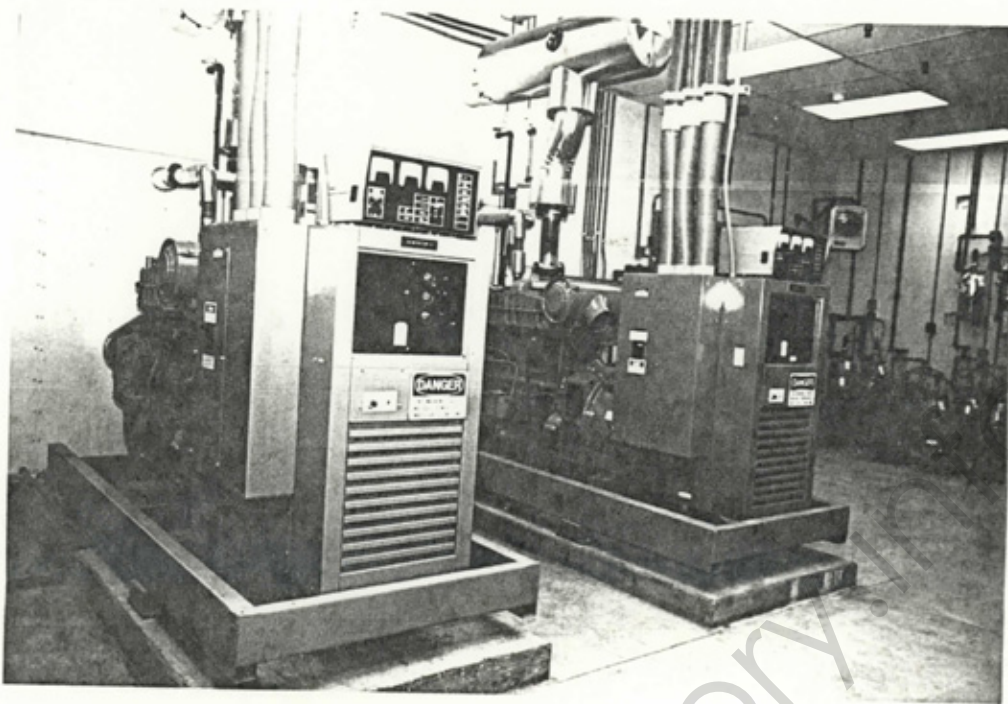
(2) LORSTA building is a low/no maintenance brick structure with ample room and an excellent layout. Emergency generator room appears well lighted, with ample working space. Spare tower hardware presently clutters floor of this room and the engineers store room. The control and main transmitter room has a raised floor, this floor's support frame work has not been adequately isolated from the concrete floor of the building. ET1 Montgomery raised a floor panel to display the floor's support columns. The isolating compound between the concrete floor and the foot of the column had smeared, this likely destroyed or damaged the isolation properties. The floor's frame work may cause Electromagnetic Interference (EMI) noise where the mounting hardware is joined.

The GENERATOR SETS.
A LOT OF SPACE IN THIS ROOM.

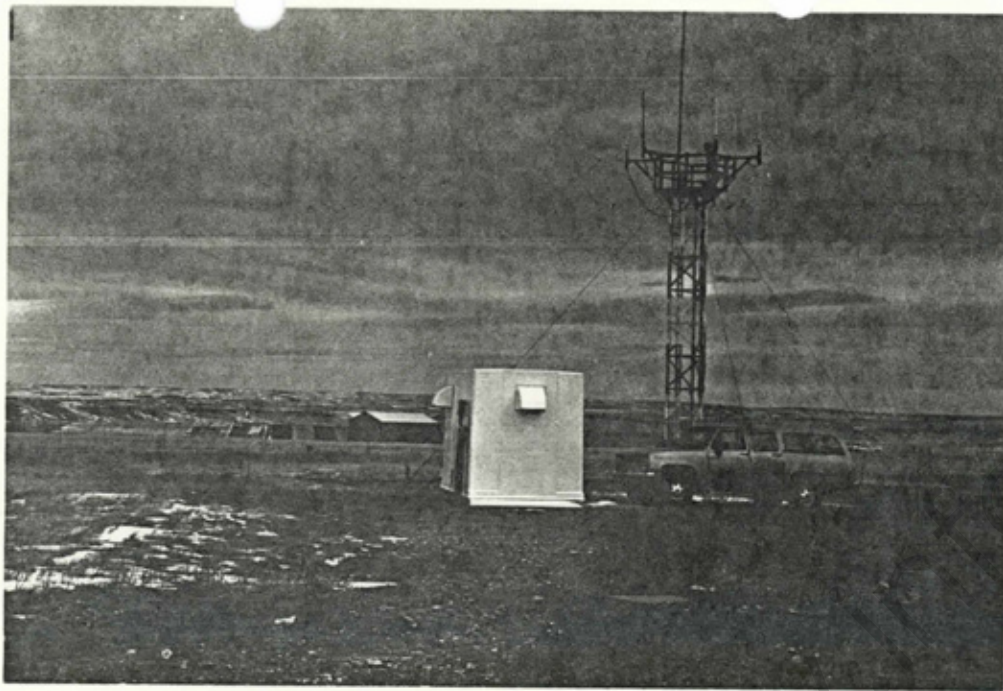
LORMONSITE
GREAT FALLS.
AT AIRPORT.
FAA MAINTAINED.

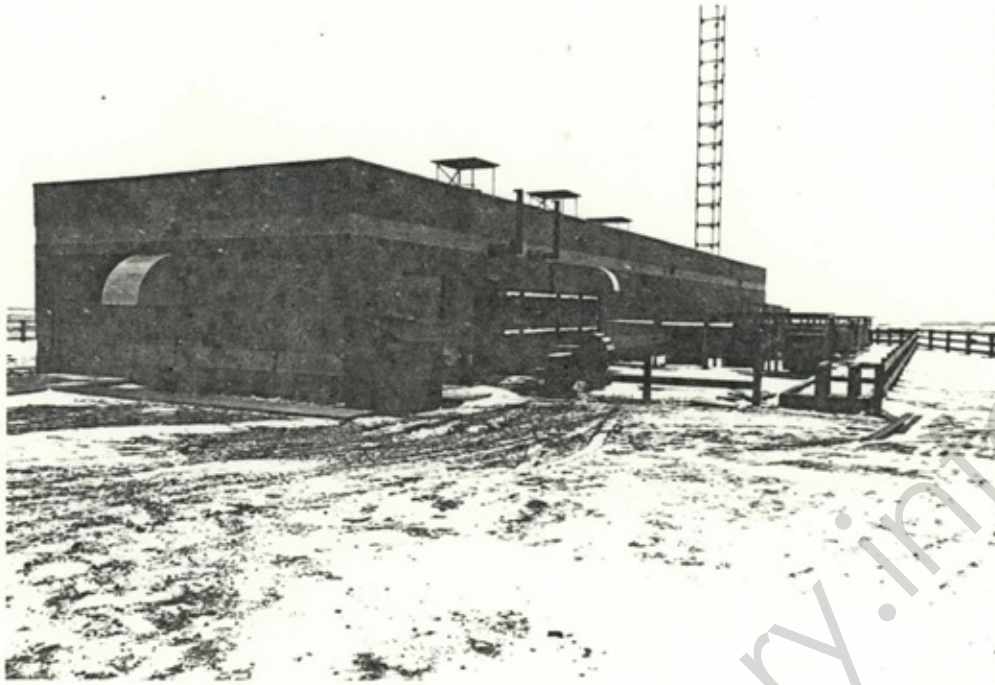
A VERY NICELY DESIGNED AND
CONSTRUCTED BUILDING, BUT
NO WINDOWS!
