United States  
Coast Guard

From: CWO4 W. G. Hamilton Jr.  
To: Chief, Navigation Division  
Via: Chief, Loran-C Branch  
Chief, Transmitter Section  
Subj: LORAN STATION ATTU AN/FPN-44B INSTALLATION SUMMARY  
Ref: (a) CG EECEN ltr of 11 Aug 1992

1. Purpose of the trip to LORSTA Attu was to finish installing the AN/FPN-44B transmitters, and change over the operating system from AN/FPN-42 to the AN/FPN-44B.

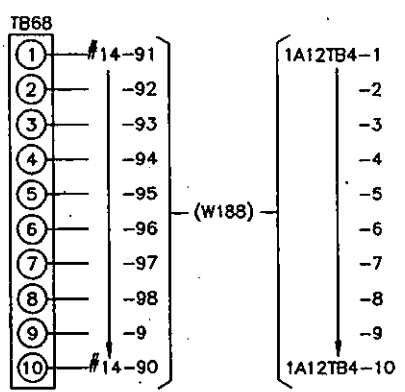
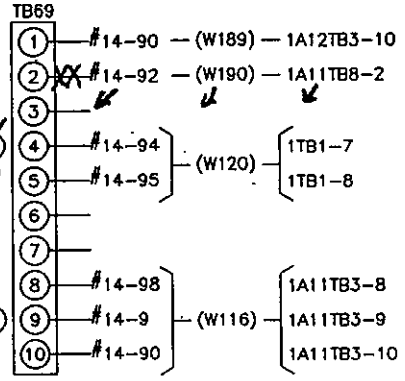
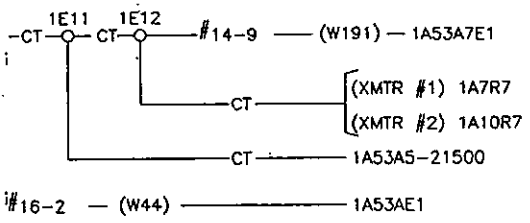
Figure 7-19. Transmitting Group OT-96/FPN-44A(1),  
Wiring Diagram (Sheet 1 of 3)

1. The AN/FPN-44B transmitters at Attu were wired according to the installation instructions, and prints. During electrical checkout it was noted that the 460 volt breaker 1A53A3CB1 would trip every time we turned the "locked on" key switch 1A53A3S2 to off position. This indication is not consistent with other 44 transmitters in the field. It is quite common to operate S2 from "on" to "off" to gain access to the master key block without having to turn off CB1 before turning S2 to off. CB1 is a mechanical device that will wear out if operated excessively, and the CB1 trip from S2 being turned off is a redundant, and unnecessary feature. When S2 is placed to the "off" position the door interlocks are interrupted, and all high voltage within the transmitter is turned off. We removed the link from S2 to CB1's under voltage trip circuit at S2. We covered the wire connectors removed from S2, with heat shrink, and tye-wrapped them back for safety.

\* NOT CONNECTED, CAUSES CBI TRIP  
WHEN "LOCK ON" KEY IS TURNED OFF
